JFAS Aviation Safety News

Date 2026.1.12 ASN60-03

Erroneous Takeoff from HND/RJTT RWY05

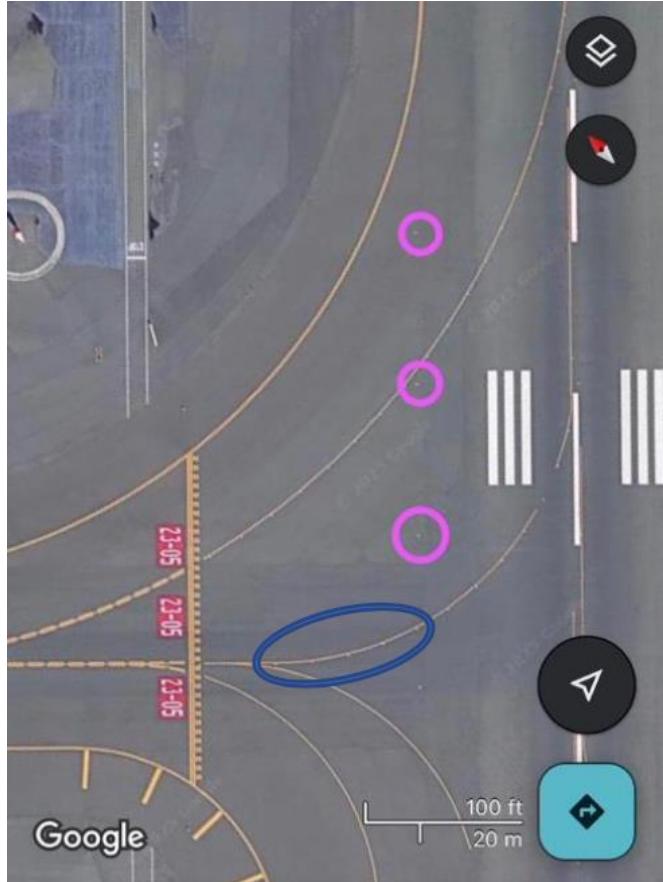
- Due to construction near the runway centerline, only the five taxi centerline lights (TCLL) extending from TWY D2 to the runway centerline after entering the runway from TWY D2 were illuminated, while the subsequent TCLL on the runway centerline side were extinguished (blue circle area in Photo 1).

<Photo1: The 5 TWCLs and the 3 RLs that were lit>

- The pilot approaches the runway along the five lit TCLL. Beyond the fifth light, an embedded RL becomes visible on the left side of the flight path (purple circle in Photo 1). RL are critically important aviation lights that indicate the runway threshold to pilots at night or in low visibility. They are therefore also installed (embedded) at regular intervals on the taxiways.

- The pilot proceeding along the southwest side marking observed that when taxiing along the five lit TCLL, the embedded RL was clearly visible on the left side of the direction of travel. Furthermore, after the fifth TCLL light, the remaining lights were out. Consequently, the RL and the fifth TCLL light appeared aligned in a straight line relative to RWY05. This created a situation where the RL could be mistaken for the (unlit) RCLL.

- The NOTAM checked at pre-flight briefing contained inaccurate information regarding the RCLL being out and partial outage of the TCLL, and there were deficiencies in the method of providing this information. For these reasons, it is possible that the pilot did not correctly recognize the status of the aeronautical lights being on or out.
- It is presumed that the pilot did not attempt to visually confirm the taxiway centerline markings and instead relied solely on the partially illuminated TCLL for taxiing.
- The pilot approaching the RWY from TWY D2 along the five lit TCLL likely shifted their gaze to the RL without seeing the taxiway centerline marking. This occurred because the illuminated fifth lit TCLL and the

RL embedded in the taxiway on the left appeared perfectly aligned with the runway direction of RWY05. Consequently, the pilot mistakenly identified that RL as the RCLL.

- The illumination direction of the 3 lit RLs lights embedded in the taxiway will be further restricted to minimize visibility to pilots taxiing from TWY D2 to RWY05 (adjusting the lights so they become visible only when the pilot is directly alongside the RL).

- RL is an extremely important aeronautical light that affects minimum weather conditions for takeoff and landing. Therefore, it must be maintained in a condition where it is reliably visible to pilots of departing and arriving aircraft. However, it is known that the 3 RLs shown in <Photo 1> have a high potential to provide misleading information to pilots of aircraft entering RWY05 from TWY D2. Therefore, measures will be implemented to ensure pilots entering from D2 cannot see the RLs until they are nearly directly alongside them. The specific methods will be determined through technical discussions with aviation lighting specialists (e.g., the Aviation Bureau's Aviation Lighting and Electrical Engineering Office).

- We suggest to increase the number of TCLLs set to unlit to match the unlit RCLLs by approximately two lights compared to the current configuration, and reduce the number of partially lit TCLLs from five to approximately three.

- It was found that when the number of partially lit TCLLs is 5, the arrangement makes the 5th TCLL and the RL appear aligned. Therefore, reducing the number of partially lit TCLLs forces pilots to rely on the runway centerline markings, encouraging their gaze to shift from the lights to the taxiway markings (if similar considerations are made at other airports, appropriate risk assessments must be conducted).

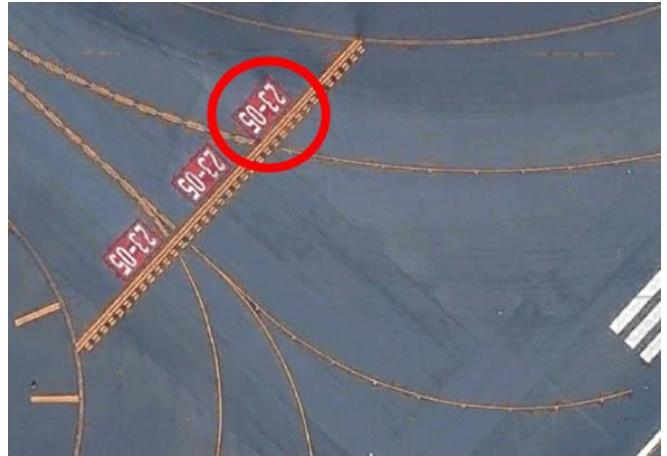
- There are two taxiway centerline markings applied from TWY D2 to RWY05. The northeast marking is for high-speed exits by aircraft landing on RWY23. The runway holding position markings also include the runway number “23-05” painted on the pavement for the northeast marking.

- While there are two TCLLs extending from TWY D2 to RWY05, as stated previously, the northeast sign is for landing. Since the TCLL design does not allow pilots entering RWY05 from D2 to see the northeast sign at

night, the northeast sign is not for takeoff. Therefore, removal of the northeast surface paint “23-05” should be considered.

<Photo 2: Surface paint requiring consideration for removal>

- Additionally, consider removing the “23-05” surface paint located near the northeast taxiway centerline marking, which is positioned before the runway hold position marking (refer to Photo 2).
