JFAS Aviation Safety News

Date 2026.1.12 ASN60-03

Erroneous Takeoff from HND/RJTT RWY05

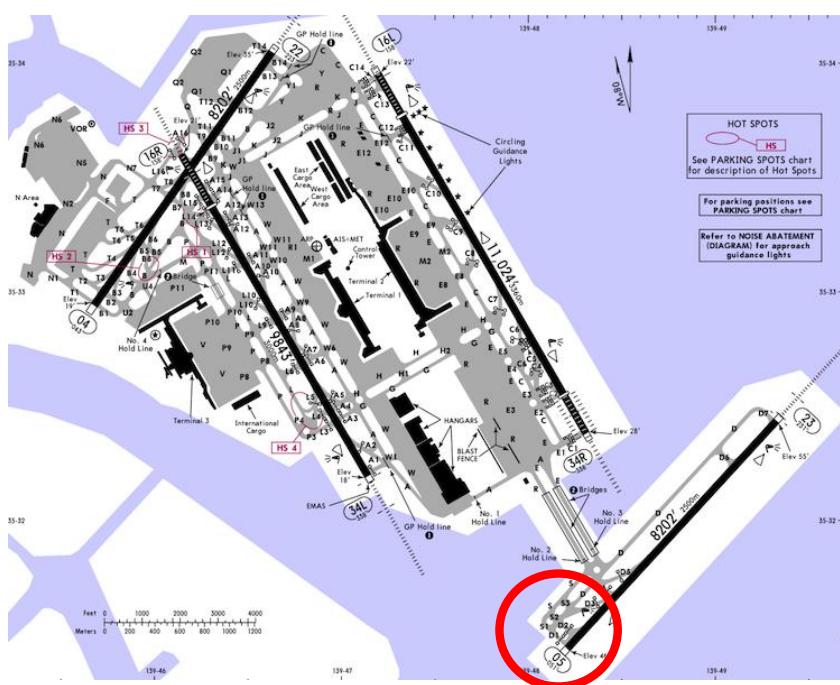
<Figure 1: Haneda Airport Layout and RWY 05 where the erroneous takeoffs occurred>

- Aircraft taking off from RWY05 will taxi from TWY D1 or D2, with the specific taxiway assigned by ATC.
- Both aircraft that damaged Runway Lights (RL) while initiating takeoff roll had entered the RWY from RWY D2, suggesting that factors potentially leading to pilot misperception may exist when entering the RWY from TWY D2.
